Contracted Scope

Project Description/Type of Construction

Major demolition in the heart of an occupied hospital campus

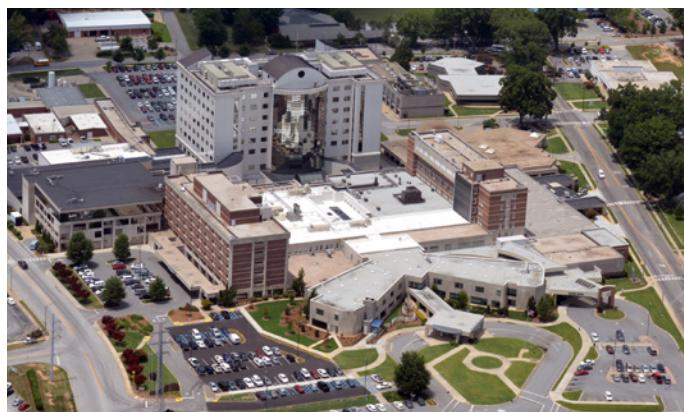
Aerial view shows Self Regional Healthcare after completion of the demolition and renovations.

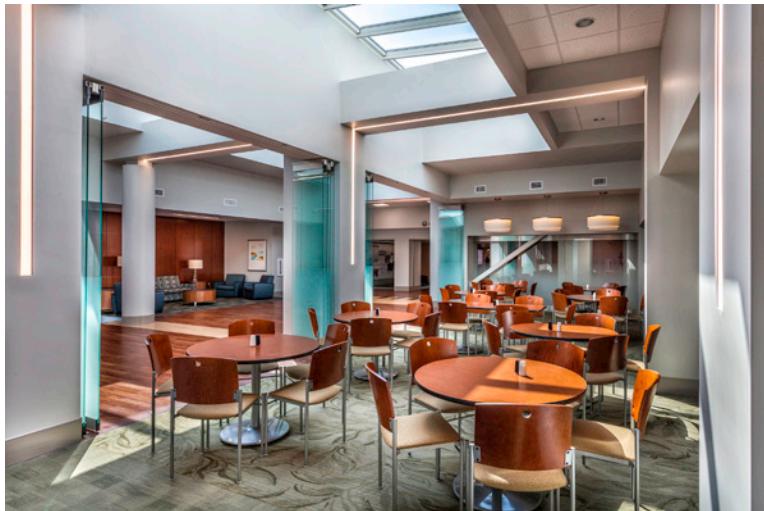
The 1950s-era structure had 10'-10" floor-to-floor heights which challenged the design team to use low profile lighting fixtures, exposed ductwork, fabric and wood panel ceilings, graphic wall coverings, and banquette seating to help transform the original first floor area into a warm and inviting dining space.

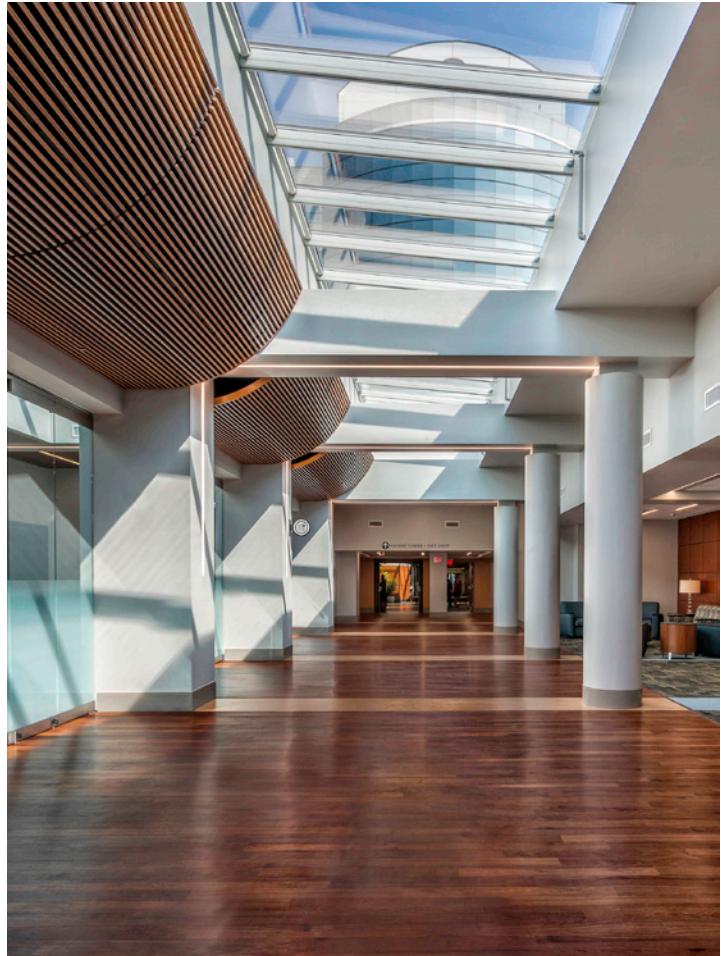
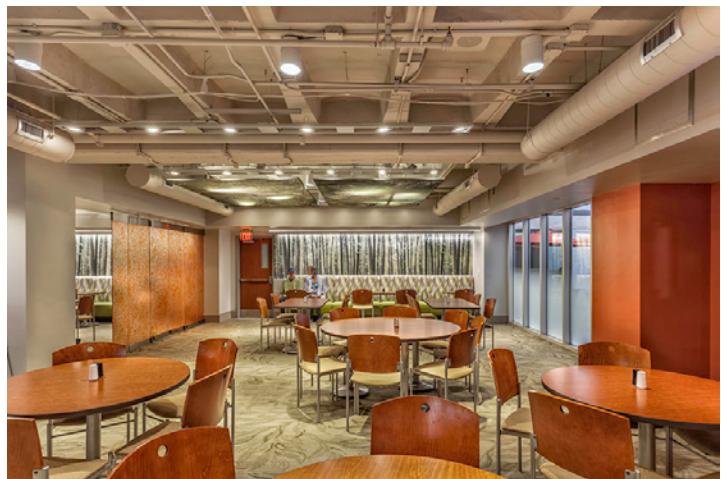
Relocating the old electrical room and revising the structure in this central area allowed raised ceiling heights, skylights, and new windows into second floor spaces above, bringing light deep into the hospital interior.

Moveable glass and resin panel systems help subdivide and open up the spaces for flexible use of the dining and main corridor according to the needs of the day.

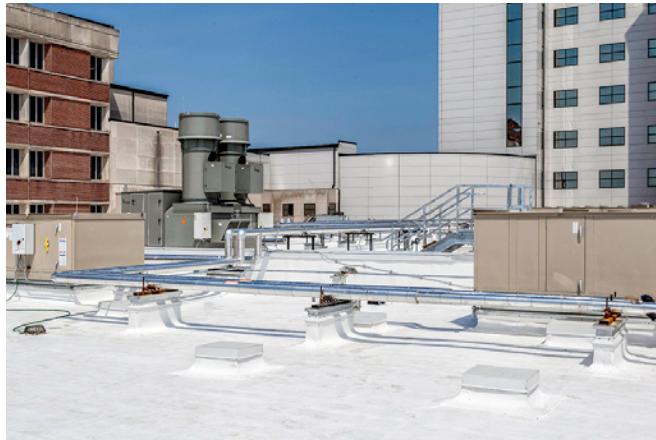
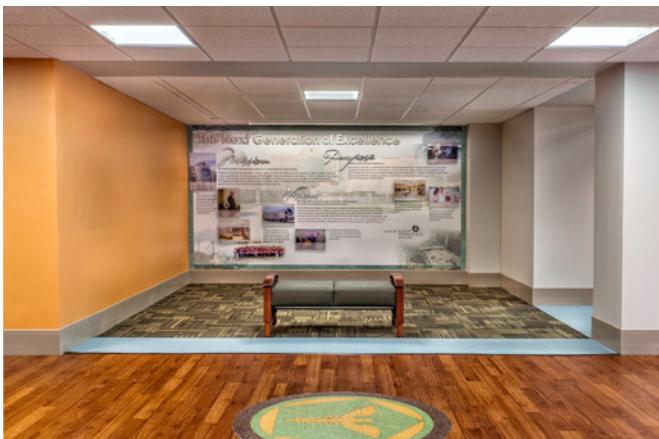
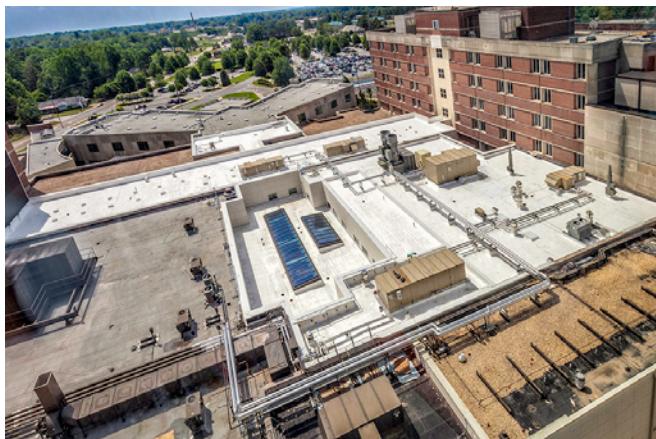
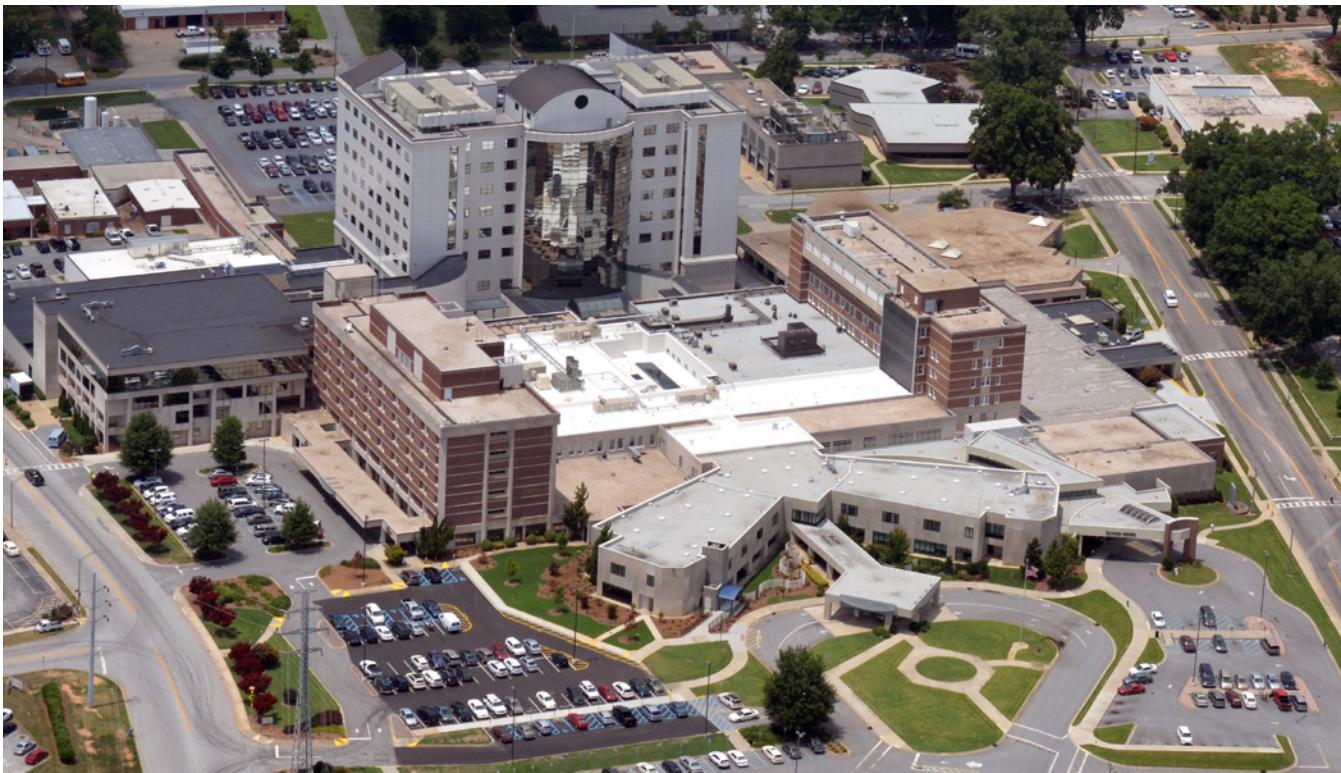
Final aerial photographs show the new roof installed over the second floor.

A temporary roof was built on top of the second floor in order to keep the bottom two floors intact and dry throughout demolition, and temporary protection was installed. Once demolition was complete, the temporary protection was removed and the final layer of roofing was installed.
